# Acute Metallosis Following Total Knee Replacement – A Case Report

### Abstract

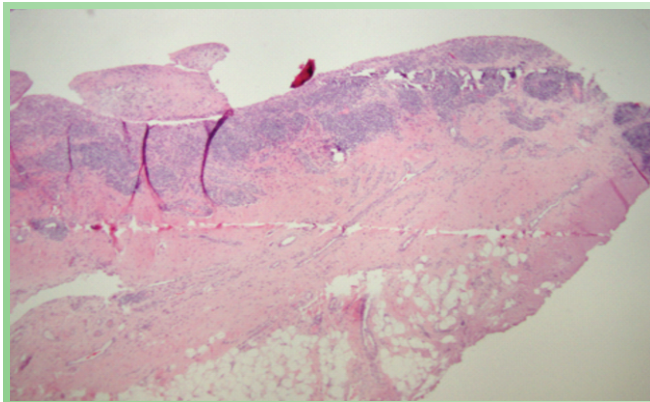
Figure 1: Lymphoid infiltrate and synovial lining cells in 59 year old male with acute-onset metallosis following total knee replacement (hematoxylin-eosin x 100).

On pathologic examination, the synovium exhibited marked chronic inflammation and hyperplasia with extensive finely granular foreign material resembling metallic debris (Figs 1 and 2). Laboratory analysis of synovial tissue for iron, chromium, and cobalt demonstrated the presence of each metal at the following levels: iron (150 micrograms/gram), chromium (17 micrograms/gram), and cobalt (14 micrograms/gram). Although reference ranges for these metals in synovium are not established, normal tissue levels of chromium and cobalt should be undetectable; iron would be detectable in tissue with hemorrhage, but the synovium did not show evidence of significant hemorrhage.

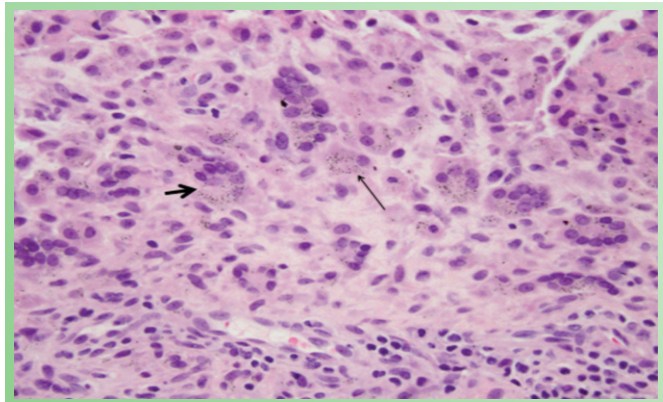
Figure 2: Intracellular metallic debris in synovial lining cells (thin arrow) and giant cells (thick arrow) in 59 year old male with acute-onset metallosis following total knee replacement (hematoxylin-eosin x 1000).

The novelty of the present case is the early onset of synovitis in a patient who exhibited pristine implants nine months after initial surgery. We believe metallosis developed acutely following deposition of iron from the three saw blades used during surgery, and that these fragments were not dislodged entirely by four liters of saline irrigation. A diagnosis of metallosis was supported by findings on pathology of finely granular foreign material resembling metallic debris in the synovium, and on laboratory analysis, the principal metal detected was iron.

Recognizing that bone cutting blades may differ in hardness, we believe it is important that surgeons have ready access to comparative ratings of blades in terms of hardness. Such information may inform surgeons in their choice of blades prior to, or even during, surgery should they encounter patients with unusually dense bone, mitigating, thereby, the need for multiple blades with the consequent risk of irretrievable debris deposition.
