# Fracture of the cemented femoral component following hemiarthroplasty in physically active patient: A case report

**Case Report:** Femoral component fracture after cemented hemiarthroplasty in a physically active 64-year-old, male patient is reported in this present article.

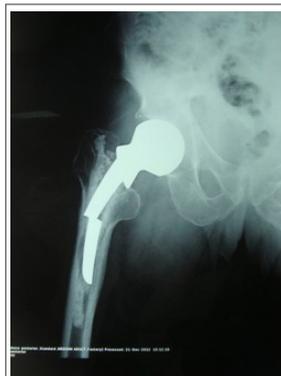
Two months earlier, he experienced a significant pain in his right hip and an analgesic drug was prescribed to him at a local hospital. As his pain increased with time, he was admitted to our hospital; radiographs taken shortly thereafter revealed a fractured femoral prosthesis (Fig.1). Physical examination revealed a healthy-appearing elder man in no acute distress with normal examination

**Figure 1:** Pre-operative X-ray AP view of left hip showing a fracture of the cemented femoral component.

Four days later, he underwent a revision arthroplasty of the right hip. A modified Watson-Jones approach was used and the proximal part of the fractured Thompson's prosthesis (51 mm sized) was extracted while the hip was dislocated. In order to extract the distal part of the femoral stem and cement, an anterior window was created at the distal part of the femur to the tip of the femoral stem, and cement mantle and the distal part of the fractured stem was extracted. The breakage occurred in the middle part of the femoral stem (Fig.2). Both parts of the femoral stem were found to be poorly fixed and easily extracted. A fully porous coated femoral stem (70 mm proximal body and 12/200 mm distal) was implanted (Fig 3). There was no post-operative complication and the patient was ambulated with partial weight-bearing on the second day after surgery. Patient was administered analgesics to reduce pain and first generation cephalosporin to prevent infection. Low molecular weight heparin was administered for 6 weeks postoperatively to prevent deep vein thrombosis. Muscle strength training was commenced on 3rd day postoperatively. Alker use was initiated in the hospital and discontinued in the 3rd week following surgery. Patient underwent regular sessions of outpatient or home-based physical therapy. Follow-up visits were performed at 6 weeks; at 3, 6, and 12 months after surgery. The Harris hip score of the patient at 1-year follow-up was 88 and there was no complication during first year follow-up.

In the present case; the pre-operative X-ray revealed that the cemented femoral stem was relatively well-fixed in the distal part when compared to the proximal part. Our patient underwent cemented hemiarthroplasty when he was 56 years old. He was a very healthy and physically active man even eight years after the surgery. However, internal fixation was not considered and hip joint was not preserved despite the relatively young age of the patient for hemiarthroplasty. Although there was radiographic evidence of a possible failure of hemiarthroplasty, the patient who was physically very active had not been informed about the possible complications of hemiarthroplasty and his activities had not been limited in the follow-up period. Furthermore, a monoblock prosthesis was used instead of a bipolar prosthesis, despite the fact that monoblock prosthesis was a more proper choice for very elderly patients (8).

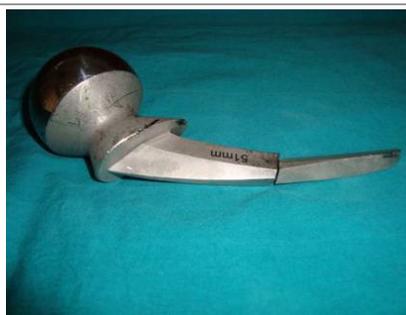
**Figure 2:** Fractured femoral stem of the bipolar prosthesis from its midportion.

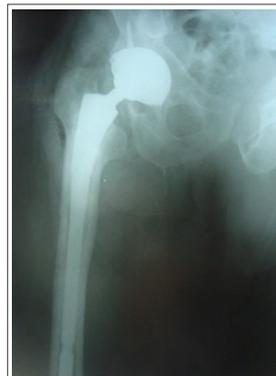
**Figure 3:** Postoperative radiograph of the patient following revision hip arthroplasty.
