Rupture of Extensively Porous Coated Stems. - A Case Series of 2 Patients

What to Learn from this Article?

Occurrence, Risk factors, Management of this Rare Complication.

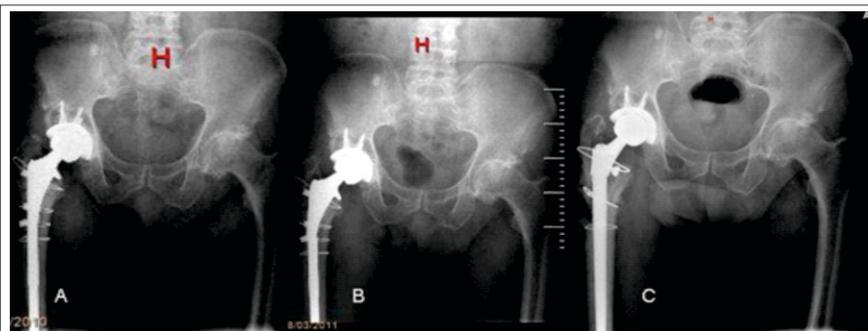
However 22 months after revision the patient consulted referring thigh pain. At that moment, plain radiographies showed no evidence of implant failure. 25 Months after hip revision the patient consulted again, explaining an increase in pain intensity, focusing mainly on the thigh while walking. This time the radiographic study revealed a transverse femoral stem fracture at the junction of the proximal and the middle third, at the level of the third cable (Fig. 1). The blood tests did not suggest a septic loosening.

Figure 1: Radiological evolution after revision surgery; X-ray AP views: 1.A.) 1 year after primary hip arthroplasty revision; 1.B.) 25 months after hip revision; the femoral stem fracture can be observed at the junction of the proximal and the middle third; 1.C.) 1 year after revision of the fatigued femoral stem

At revision surgery, proximal release of the femoral stem was easy because it was loose. The distal portion of the femoral component was removed by using a series of hollow trephines (Depuy, Warsaw, Ind®) since the distal portion of the implant was well fixed. The new femoral component implanted was a non-cemented, 200-mm-long 16mm-diameter modular stem with a 60mm modular metaphysis (Lima Corporate®) (Fig2). Intra-operative cultures were negative; and the patient was discharged after a satisfactory postoperative evolution, with a total hospital stay of 13 days. At one-year follow-up, the patient walks with the aid of one stick and refers no pain, with a Harris Hip Score 79.19.

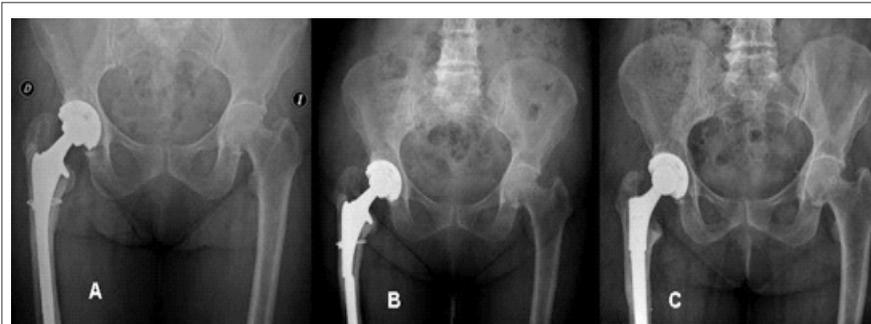
In October 2009 the patient consulted referring medial thigh pain. Radiographies were considered normal. In February 2010 the patient suffered a sudden increase in the thigh pain and disability. The radiographic study revealed a femoral stem fatigue fracture just proximal to the diaphyseal isthmus [Fig.2]. She underwent revision surgery: as in the previous case, the proximal part of the broken femoral stem was released easily due to its loosening; on the other hand, the distal part of the

Figure 2: Radiological evolution after revision surgery; X-ray AP views: 2.A) 1 year after primary hip revision; 2.B) 37 Months after revision surgery; the femoral stem fractured at the junction between the proximal loose part and distally well-fixed zone and 2.C) 1 year after revision of the fatigued femoral stem

femoral stem was firmly attached to the bone and again a series of hollow trephines (Depuy, Warsaw, Ind®) were used. In order to expose the distal femur and to guide the trephines, a transverse osteotomy was performed one centimetre distal to the rupture site. Due to the increase of the diameter of the medullar canal after using the trephines, the failed femoral stem was revised to a non-cemented, bowed 16mm-diameter, 200-mm-long, modular stem with a 70 mm modular metaphysis (Lima Corporate®). The patient was discharged after an uneventful postoperative period of 15 days. At 18 month follow up the patient is walking with the aid of one crutch. Harris Hip score is 72.7 and the follow-up radiographies show a correct integration of the implant [Fig.2].
