Failure of Polyethylene Insert Locking Mechanism after a Posterior Stabilised Total Knee Arthroplasty- A Case Report

Introduction: Disengagement of polyethylene insert used in total knee arthroplasty is a rare but serious complication. Still rarer is disengagement because of failure of tibial insert locking mechanism. We report a previously unpublished complication of polyethylene insert locking mechanism failure in a 10-months-old posterior stabilized total knee arthroplasty in a 70-year-old woman with osteoarthritis for whom Attune (Depuy) knee implant was used.

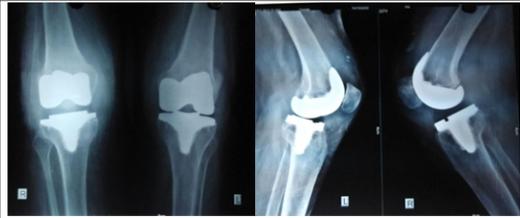
Figure 1: Immediate post op radiographs after index surgery.

A 70-year-old female underwent (Attune, Depuy) primary bilateral posterior stabilised total knee arthroplasty (May '2014) for osteoarthritis in a private hospital. The femoral and tibial components were size 4 and polyethylene size was 10mm. Immediate post-operative X-ray shown in (Fig.1). She had been functioning well post her arthroplasty for five months, when she had a fall and sustained injury over right hip and was treated with Cemented Bipolar Hemiarthroplasty (Sep'2014). Ten months after index surgery, she sustained trivial fall and presented to the same hospital with knee pain and swelling, where the right knee prosthesis was found to be dislocated (Fig.2). An attempted closed reduction under anaesthesia failed, after which she was referred to our centre with an unstable, painful, swollen right knee in a long knee brace. The physical examination at the time of admission showed posterior sag of the tibia (Fig.3), fullness in the postero-lateral corner, quadriceps muscle atrophy without any neurovascular deficit of lower leg. Postero-lateral dislocation was confirmed with radiographs. Surgical error as a

In our case, immediate postoperative radiographs after index surgery showed posterior slope with flexion of femoral component. Patient functioned well for 10 months after surgery, hence, surgical error at the time of index surgery can

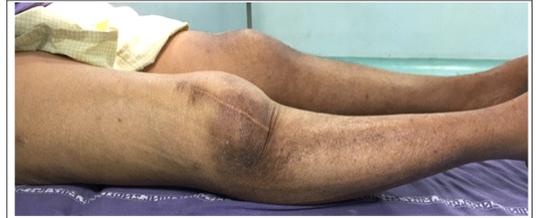
Figure 3: Clinical picture Right knee with posterior sag.

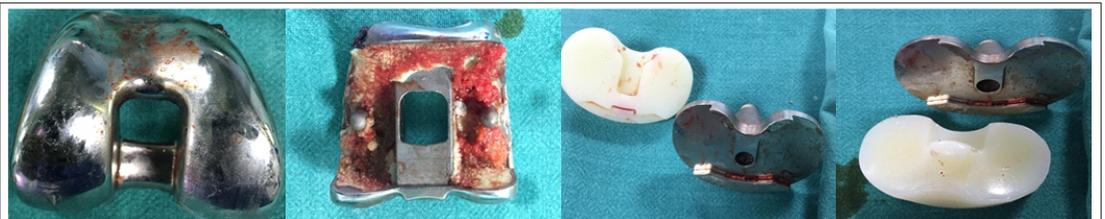
Figure 5: Retrieved components showing fatigue wear of locking mechanism in polyethylene.

locking mechanism [7]. In our case, there was complete disengagement of the polyethylene. Retrieval analysis could not be done so it is difficult to say if the failure of locking mechanism is related to design flaw.

There are many limitations in our case report.. We could not exactly point out the exact mechanism of locking mechanism failure and the retrieval analysis of the explanted polyethylene was not done.

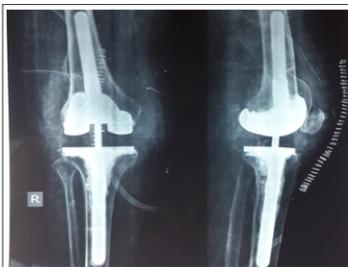
Figure 6: Post-operative radiograph with stemmed ,constrained component(TC 3, Depuy).

An open reduction surgery was planned. On exposure, polyethylene was found in the postero-lateral corner of the knee (Fig.4). We were not sure that revising the polyethylene alone would suffice as the poly and locking mechanism was of a relatively new design and hence, it was decided to proceed with revision of the components. Revision was done with stemmed components, distal femoral augments and a constrained prosthesis (Fig.5) (Total Condylar 3, Depuy). Intra-operative cultures were negative. The patient had an uncomplicated post-operative course.

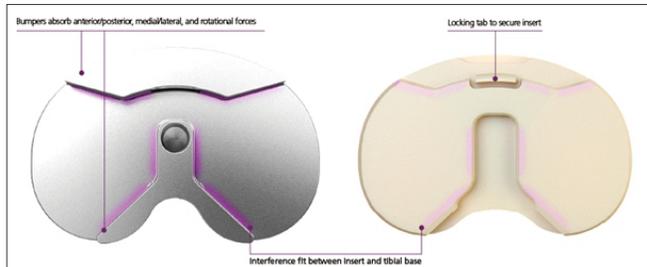
Figure 7: Locking mechanism in Attune system (DepuySynthes).

Disengagement of locking mechanism of the insert has been described in revision total knee arthroplasty [8, 9]. To our knowledge, disengagement of polyethylene of Attune Knee system (Attune, Depuy), which has been recently introduced, has not been reported in the literature. The design features include gradually reducing femoral radius, S-curve design of cam and spine, AOX (anti-oxidant) polyethylene and LOGICLOCK™ tibial base that has a central
