Fracture of the Anterior Locking Flange of a Total Knee Arthroplasty Polyethylene Liner Presenting with Pain following Knee Replacement

Introduction: Fracture of the modern polyethylene insert of a total knee arthroplasty is rare. We describe the first case of a fractured anterior locking flange of the commonly used Depuy Press-fit Condylar (PFC) Sigma prosthesis.

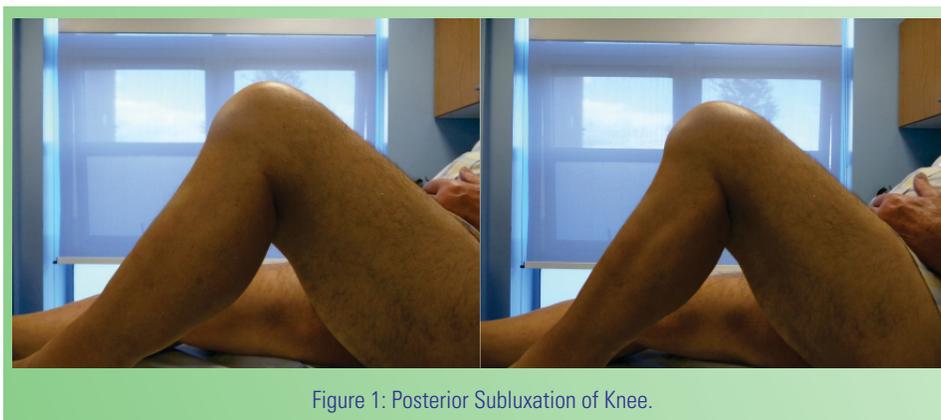
operatively, complaining about pain in the knee, with episodes of swelling and instability. Interestingly, he was able to sublux his knee posteriorly, using his hamstrings [Fig 1]

Figure 1: Posterior Subluxation of Knee.

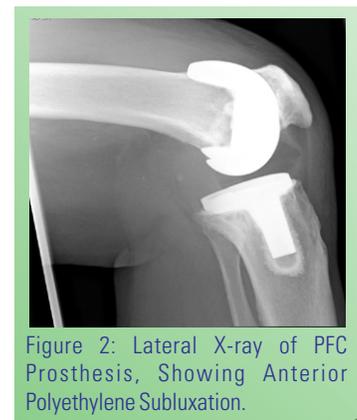
Radiographs showed an inverse shadow of the polyethylene liner protruding anteriorly over the tibial tray. There was no sign of loosening of the tibial tray or femoral component [Fig 2]. This suggested anterior polyethylene subluxation: this subtle sign has been described as indicative of failure of the locking mechanism in posterior-stabilized prostheses [3].

Figure 2: Lateral X-ray of PFC Prosthesis, Showing Anterior Polyethylene Subluxation.

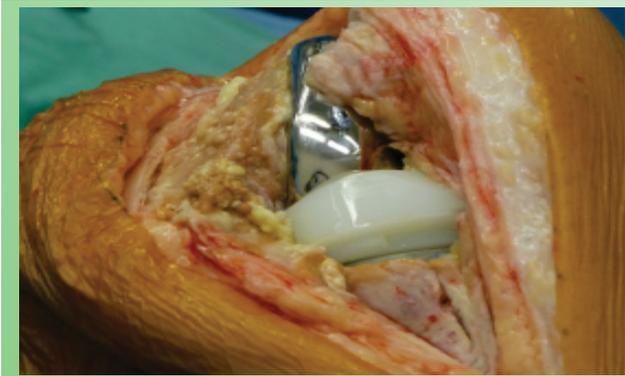
He was operated on one month later. On making the arthrotomy of the knee, it was apparent that the polyethylene liner had dissociated from the tibial tray and was protruding anteriorly [Fig 3]. On removing the tibial insert it was found that the anterior locking flange on the under surface had fractured from the liner, allowing it to dissociate from the tibial tray. There was a line of wear along the base of the anterior aspect of the stabilising peg, as well as the posterior aspect of the tip of the peg [Fig 4]. This was attributed to abnormal articulation with the femoral component in the dissociated position. The femoral and tibial components were securely attached and undamaged. They were, therefore, left in-situ and the polyethylene liner was replaced with a new size 3, 15mm stabilised insert.

Figure 3: Polyethylene Liner Protruding Anteriorly from Tibial Tray.

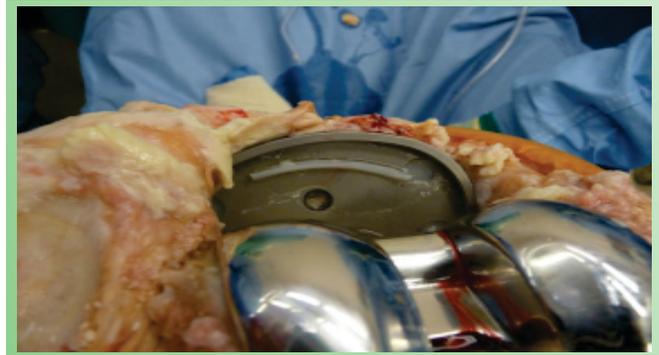
Figure 4: Line of Wear along the Base of the Anterior Aspect of the Stabilising Peg and Posterior Aspect of the Tip of the Peg.

On a thorough search of the literature no reports of fracture of the anterior locking flange on the tibial surface of a PFC Sigma liner could be found. Failure of this aspect of the liner could have occurred at initial insertion, where impaction of the liner is required to secure it into the tibial tray. This may have accounted for the discomfort this patient reported in the second post-operative year, however this would not explain the regression of these symptoms and several years of a pain free stable TKA. A manufacturing fault could have been to blame; this has been reported previously in the Kinemax Plus knee system [16], where only a 75% implant survival rate at 9 years was found. Conclusions from this study suggested that type 2 fusion defects were present in the ultra high molecular weight polyethylene liners of explanted and unused tibial inserts, resulting in wear, fracture and implant failure. Results were compared with the PFC Sigma TKA where no such problems were found. The fact the articular surfaces of the tibial liner was completely intact and showed no sign of wear in our case, would reduce the possibility of a manufacturing fault in the polyethylene. The insults to the tibial post were likely a result of the femoral component

articulating on the subluxed liner. Repetitive stress on the anterior aspect of the liner may have lead to the breakage. Though the cause of this stress is not clear with the gentleman having similar activity levels, mass and range of motion as many following this surgery. Overall the cause of the failure of the anterior locking flange remains uncertain.
