# Broken Pieces of Circlage Wire Lying in Soft Tissue Envelope Around Knee Joint: A Case Report and Review of Literature

**Introduction:** The migration of circlage wires used in tension band wiring construct of patella fractures in the posterior soft tissue envelope surrounding the knee joint has been rarely reported.

**Case Presentation:** A 60-year-old woman presented to us with pain over medial aspect of right knee joint. She underwent open reduction and internal fixation for a patellar fracture which she sustained 4 years back and subsequently underwent kirschner wire (k wire) removal for the same around 2 years back. X-rays of the knee joint shows that the circlage wire used in tension band construct which was left in place had broken into multiple pieces and was lying in the soft tissue envelope surrounding the knee joint and one piece migrate to the popliteal fossa. On examination patient did not had distal neuro-vascular deficit. The pain of the patient was due to the osteo-arthritic changes in her medial side of knee joint rather than broken wire pieces. Patient was advised to undergo total knee replacement along with subsequent removal of broken wires but patient refus

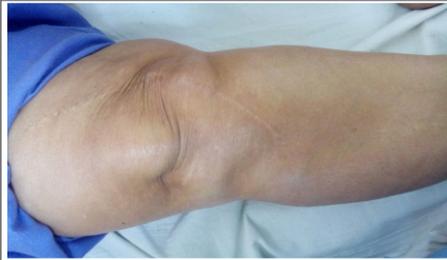
climbing stairs. On physical examination there was tenderness along the medial aspect of knee joint and a curved scar mark was present over the anterior aspect of knee joint (Fig.1). While history taking the patient told us that she had a patella fracture around 4 years back which was treated by open reduction and internal fixation and she subsequently underwent implant removal 2 years back. The patient had full range of motion (ROM) at knee joint (Figs. 2, 3) and moderate pain was observed on medial side while flexing and extending knee joint. There was no history of any recent trauma to knee joint. A provisional diagnosis of osteoarthritis knee joint was made and weight bearing standing antero-posterior and lateral x-rays of left knee joint were ordered.

**Figure 1:** Showing scar mark over anterior aspect of knee joint.

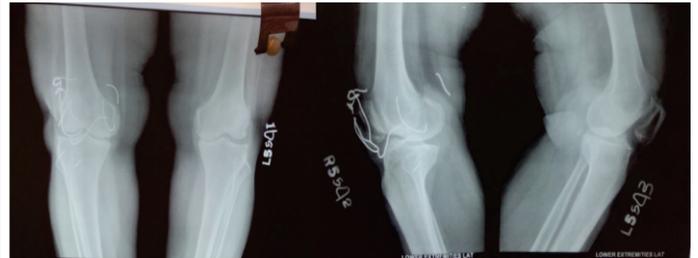
On X-rays it was found that multiple pieces of broken circlage wire were present around knee joint and one piece had migrated posteriorly (Fig. 4). On examination patient did not had distal neurovascular deficit and patients pain was not related to these broken pieces, rather it was due to degenerative changes in the knee joint. It is believed that the surgeon who did implant removal

**Figure 4:** Showing weight bearing anteroposterior and lateral radiograph of knee joint with broken pieces of wire

removed only the K wires leaving behind the circlage wires which broke into multiple pieces over the passage of time due to the repeated stresses at knee joint. Patient was advised to undergo total knee replacement along with subsequent removal of broken hardware as potential undue complications can occur because of broken hardware in the form of damage to neurovascular structure due to migration of pieces posteriorly. It was also explained to the patient that cases have been reported where broken pieces migrate to heart and sternum and produce life threatening complications. However, patient refused to undergo any type of surgery. she was warned and told to be alert whenever the nature of her pain changes or she experiences new onset of symptoms which is different in character from the pain she is experiencing now and was kept on regular follow up.

In our case broken pieces of circlage wire lying in soft tissue of knee joint with one piece migrate posteriorly to popliteal fossa however, patient pain was due to osteoarthritic changes rather than the broken pieces of wire. So she was kept on regular follow up as patient was not willing for any type of surgery. Therefore whenever the surgeon uses K wires or circlage wires he/she should keep all the complications in mind which can result from local as well as distant migration of broken wires. The wires may remain asymptomatic or they can migrate into joints causing damage to the cartilage or can impinge upon neurovascular structures causing pain or can injure neurovascular structures leading to life threatening haemorrhage or broken pieces can migrate via venous system travelling as far as upto heart leading to tamponade [15]. In order to avoid undue complications due to hardware failure, the surgeon must remove the sharp hardware like k wires and circlage wires after union of fracture patella.
