# A Soft- Tissue Injury Diagnosis in Knee Replacement Patients cannot be made without a Plain Radiograph

Rute Castelhana<sup>1</sup>, Sunny Deo<sup>1</sup>

DOI:  
10.13107/jocr.2021.v11.i04.2150

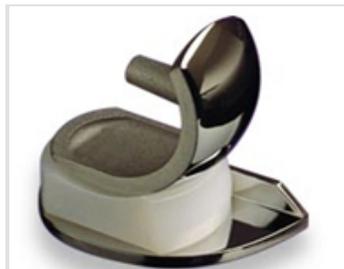
**Figure 1:** Normal appearance of medial unicompartmental knee replacement.

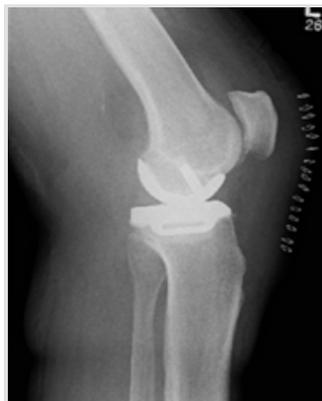
**Figure 3:** Lateral radiographic views of a normally positioned unicompartmental knee replacement.

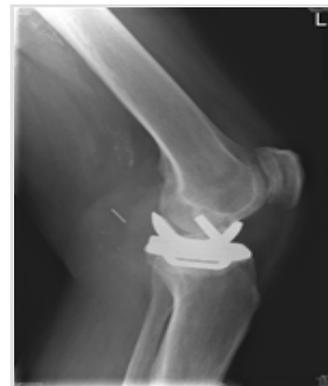
At the 1 year follow-up appointment, radiographs (Fig. 4) were obtained which indicated that the polyethylene insert was in fact dislocated posteriorly toward the popliteal fossa, into soft tissues adjacent to the neurovascular bundle, with consequent direct contact of metal components.

**Figure 3:** Lateral knee X-ray demonstrating contact between metal components, with posterior dislocation of tibial polyethylene bearing component.

The patient underwent a surgical exploration which revealed that both the femoral and tibial components were severely abraded, with consequent severe metallosis within the

synovium. The polyethylene insert was encapsulated in thick fibrous tissue in the posterior soft tissues at the back of the knee which caused a difficult dissection close to the popliteal neurovascular structures. The initial incision had to be extended and UKR implants were removed, due to the degree of abrasive damage, to allow for a radical synovectomy and limited bone resection to remove the metallosis and for safe removal of the mobile bearing and its pseudocapsule. A total knee replacement (TKR) was undertaken with the patient mobilizing in a standard fashion, after which, they were discharged a 3 days later, without noted perioperative problem or complication. The patient went on to make a smooth recovery and was reviewed again at 1 and 5 years post-revision surgery.
