# Massive Eccentric Wear of the Acetabular Cup after Polyethylene Liner Abrasion in Hip Arthroplasty may lead to a high Risk of Injury during Revision Surgery

Progressive eccentric wear due to liner abrasion in hip arthroplasty may occur rapidly and in cases with excessive wear characteristics, appropriate knowledge of implants and planning of revision surgery is crucial.

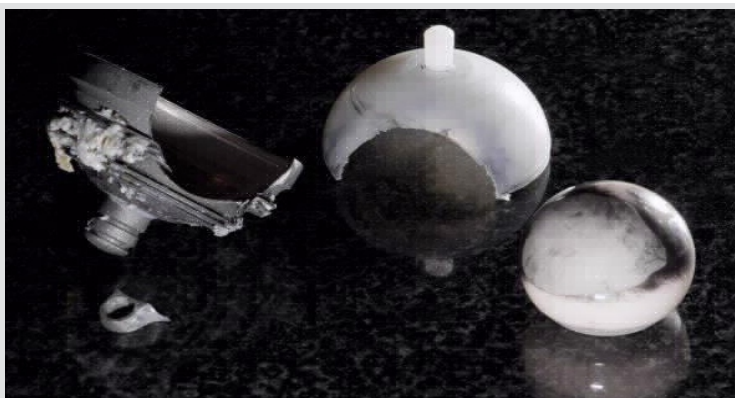
**Figure 3:** Implants after removal showing massive wear and razor-sharp edges.

component had worn completely through the cranial polyethylene liner and rim of the acetabular component (Fig. 3). During further debridement of the capsule, the orthopedic surgeon cut his index finger at the razor blade sharp edges (Fig. 4) of the worn acetabular cup. After removing the cup without any major loss of the acetabular bone stock, a DS Evolution cup (Mathys AG, Bettlach, Switzerland) was cemented into the acetabulum. The Zweymüller® stem remained stable, so it was left unchanged. The hip was reduced with a 28 mm Metasul® CoCrMo head with a 14/16 taper within the 28/48 mm highly cross-linked polyethylene inlay. Afterward, the joint showed excellent stability (Fig. 5).

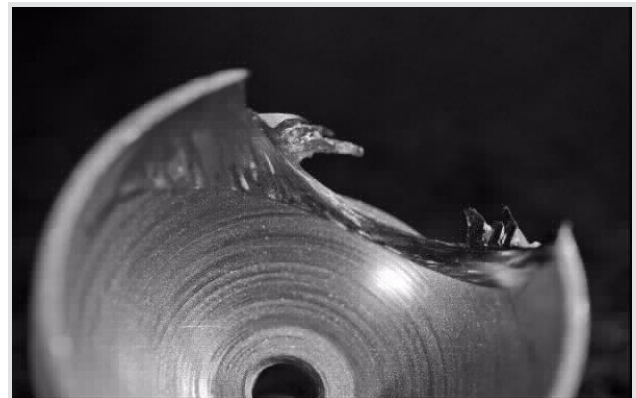
**Figure 4:** Detailed view of removed cup with razor-sharp edges.

radiograph made every 2–3 years thereafter. Patients with a higher risk of developing osteolysis, for example, younger and more active patients, should be monitored more closely. In the unfavorable event of symptomatic and excessive wear characteristics after hip arthroplasty with or without osteolysis, the revision surgeon needs adequate knowledge of the past and actual implants available on the market, appropriate interpretation of the medical imaging modalities, and suitable planning to avoid unexpected intraoperative issues. In addition, in cases with excessive eccentric wear of the cup after complete polyethylene abrasion, the revision surgeon should be warned of razor blade sharp edges to prevent momentous injury.
