Catastrophic Failure of the Acetabular Polyethylene Liner in Ceramic-on-Polyethylene Total Hip Arthroplasty

Givenchy Manzano¹, Rayna A. C. Levin², Michael B. Mayor², Ran Schwarzkopf¹

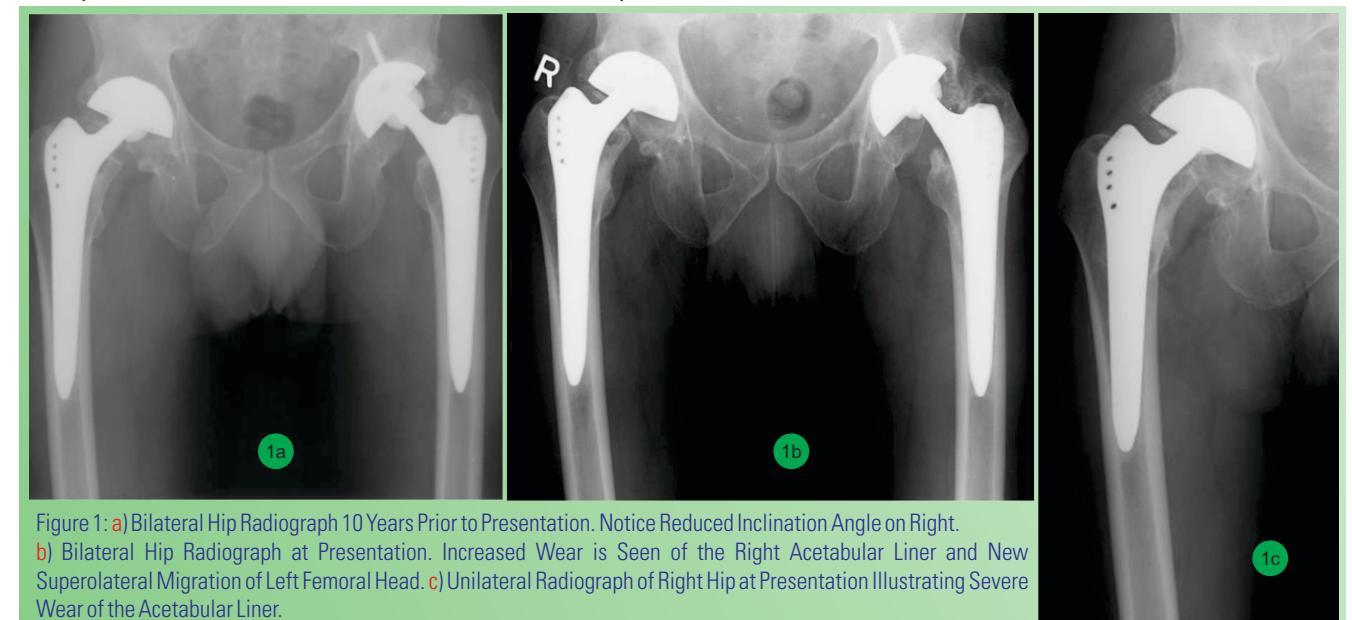
acetabular shell resulting in aseptic loosening, severe Infection work up was negative revealing a slightly elevated osteolysis, and periarticular metallosis. We suggest that this ESR of 16 mm/hr (N 0-15) but normal CRP of 0.5 mg/dl (N 0 failure is mainly due to the use of a non-crosslinked to 0.7), hip joint aspiration reveled a cell count of 212 white polyethylene liner, the patient's highly active lifestyle, and blood cells (WBC) cells/cu mm and 63% polymorphonuclear cells. Radiographs of bilateral hips revealed severe osteolysis, heterotopic ossification, wear of the acetabular liner, bony impingement of the femoral

migration of the femoral head [Fig 1]. Acetabular cup the ceramic femoral head showed an area of ceramic-onabduction angles were 21° and 50° in the right and left hip metal contact, severe metal transfer, and a severe loss of respectively. Femoral offset was 5.6cm (right) and 4.0cm surface smoothness [Fig 2C]. The unworn areas of the (left). Due to the severe wear and pain in both hips with ceramic head had an average surface roughness (Ra) of 1nm failure to respond to conservative non-surgical treatment, to 2nm while the worn areas had Ra of 2500nm to 3500nm. the patient was indicated for staged bilateral total hip With regards to the cemented titanium acetabular cup, the non-articular surface showed abundant bony ingrowth with On the right, intraoperative findings revealed complete good interdigitation, and no in vivo damage. The articular wear of the ceramic femoral head through the polar aspect surface showed an area of central wear caused by the ceramic-

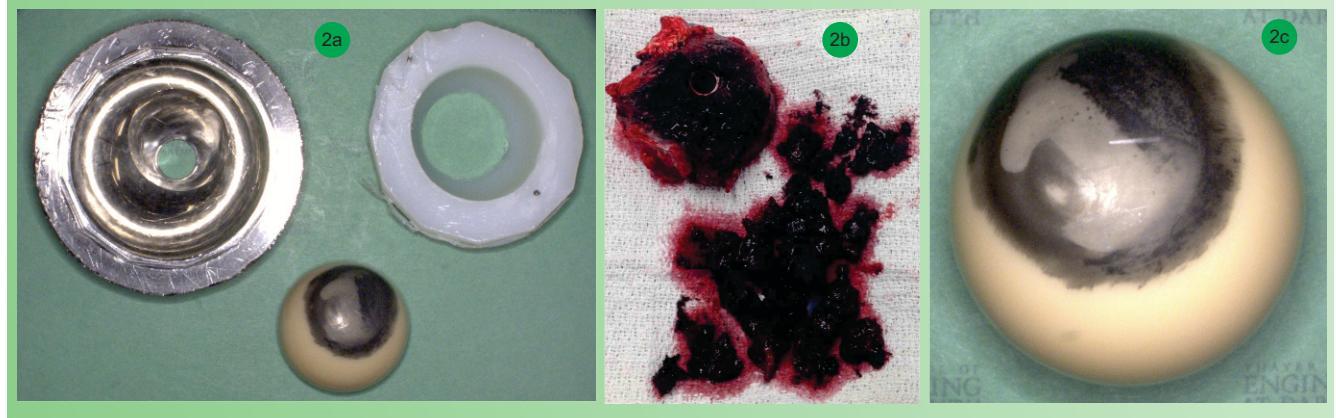
Figure 2: a) Retrieved Components from the Right Hip Illustrating Complete Wear through the Acetabular Liner and Metallosis on the Ceramic Bearing. b) Intraoperative Illustration of Severe Metallosis Periartcularly due to Long Term Wear of the Acetabular Cup by the Ceramic Bearing. c) Retrieved Ceramic Head Showing Metallosis and Loss of Surface Smoothness.

of the polyethylene liner into the acetabular cup [Fig 2A], on-metal contact. acetabular trabecular metal cup (Zimmer; Warsaw, IN) was publication. press fit, in the position of maximum bony contact, with the support of multiple screws. A cemented highly crosslinked polyethylene liner was cemented into the acetabular cup at 45° of inclination and 20° of anteversion. The ceramic bearing was replaced with a VerSys Hip System 36mm femoral head with a 12/14 taper (Zimmer; Warsaw, IN). Revision of the left hip was performed a few months following the right hip revision, moderate proximal femur osteolysis was present with moderate polyethylene liner wear. On both the left and the right hip it was decided to retain the femoral stem after it was inspected intra operatively and found to be stable and in proper version.

causing severe metallic wear and indentation in the cup Post-operative weight bearing status was foot flat weight with severe metallosis and tissue destruction in the bearing for a period of 6 weeks with weight bearing periarticular region [Fig 2B]. Extensive heterotopic progressively increased during a period of 6 weeks to full ossification in the abductor muscles was also noted. Severe weight bearing at 3 months. At last follow up (12 months), the osteolysis and bone loss was present behind the acetabular patient was ambulating with no assistive devices without any cup, especially at the medial and superior posterior walls as complaints or pain. Postoperative radiographs showed no well as part of the posterior column. Cancellous bone was signs of loosening, misalignment, fracture or increased used to repair contained areas of gross osteolysis. A new osteolysis [Fig 3]. The patient agreed to have his case used for

The polar polyethylene wear pattern and degree of term survival rates from 10 to 20 years have been more volumetric wear observed in our patient was surprising [Fig 2A]. It is plausible that the continued participation in athletic activities despite the patient's chronic hip pain contributed to a "boring" mechanism of wear, which together with a 21° abduction angle would concentrate wear towards the center of the cup. Charnley and colleagues were the first to report The use of non-crosslinked polyethylene was a major risk that prosthetic femoral heads "bored" into polyethylene factor for catastrophic failure in this patient. Non- liners, creating for itself a cylindrical path. Multiple wear crosslinked polyethylene has been shown to have higher vectors most likely added another component to the degree of

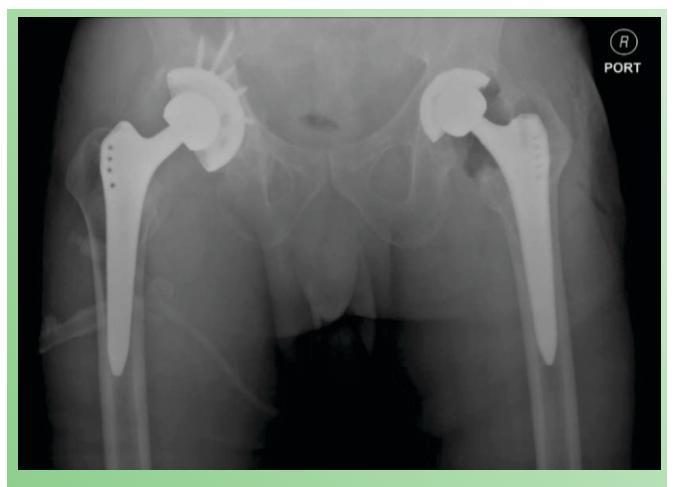
Figure 3: Post-operative Bilateral Hip Radiograph Showing Stable Components.
