Femoral Perforation after Hemiarthroplasty – Life goes on for 7 years!

Rajeev Joshi¹

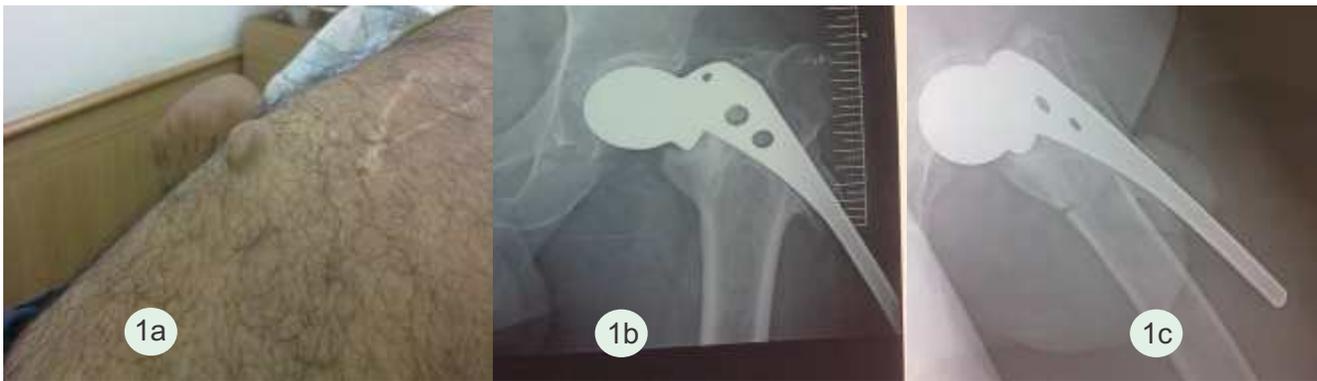
Fig. 1a: Protruding mass along the lateral aspect of the thigh of the patient with V shaped scar marks of previous surgery. Fig. 1b,c: Malpositioned Austin Moore prosthesis with perforation of the lateral femoral cortex. Note the growth of new bone extending along the femoral stem.

hard swelling, with mild tenderness on deep pressure (Fig. 1a). There was no warmth in that local area or sinus and patient was afebrile. He had a shortening of 3 cms which was supra-trochanteric and there was mild pain in the greater trochanteric area. Hip flexion was 90° with abduction of only a jog of movement; adduction was 15° with extension of 10°. There was a fixed external rotation of 15° with further external rotation of 10°. Patient had a Trendelenburg gait and was able to walk with not much discomfort. X rays were ordered and showed a grossly malpositioned Austin Moore prosthesis which has perforated the lateral femoral cortex (Fig 1b,c). At the point of exit of the implant a bony outgrowth was found to extend along the prosthesis stem (which possibly added to the stability). Considering his age he has been advised THR as and when he would want it. Patient was otherwise carrying out his functions fairly well according to his expectations and so he left with his functioning implant!

was some pain at the external protruding stem, except which he was doing pretty fine. The acetabulum also did not look compromised on recent radiograph. A bony extension was seen growing along the stem which might have added to the stability along with a varus collapse of the implant. Patient had limited range of motion and was walking with trendelenberg gait, however even these limitations did not affect his life to an extent for which he would like to undergo a repeat surgery. Possibly this is one of the first case with such long follow up of perforated uncemented stem and with a surprising retention of functional ability.
